Technical Inspection Report
Bureau of Ordnance Group

6
OPERATION CROSSROADS.

TESTS 'A' AND 'B'.
VOLUME IV.
PART X. PHOTOGRAPHIC
APPENDIX [U].

GUNS AND MOUNTS PHOTOGRAPHIC INDEX

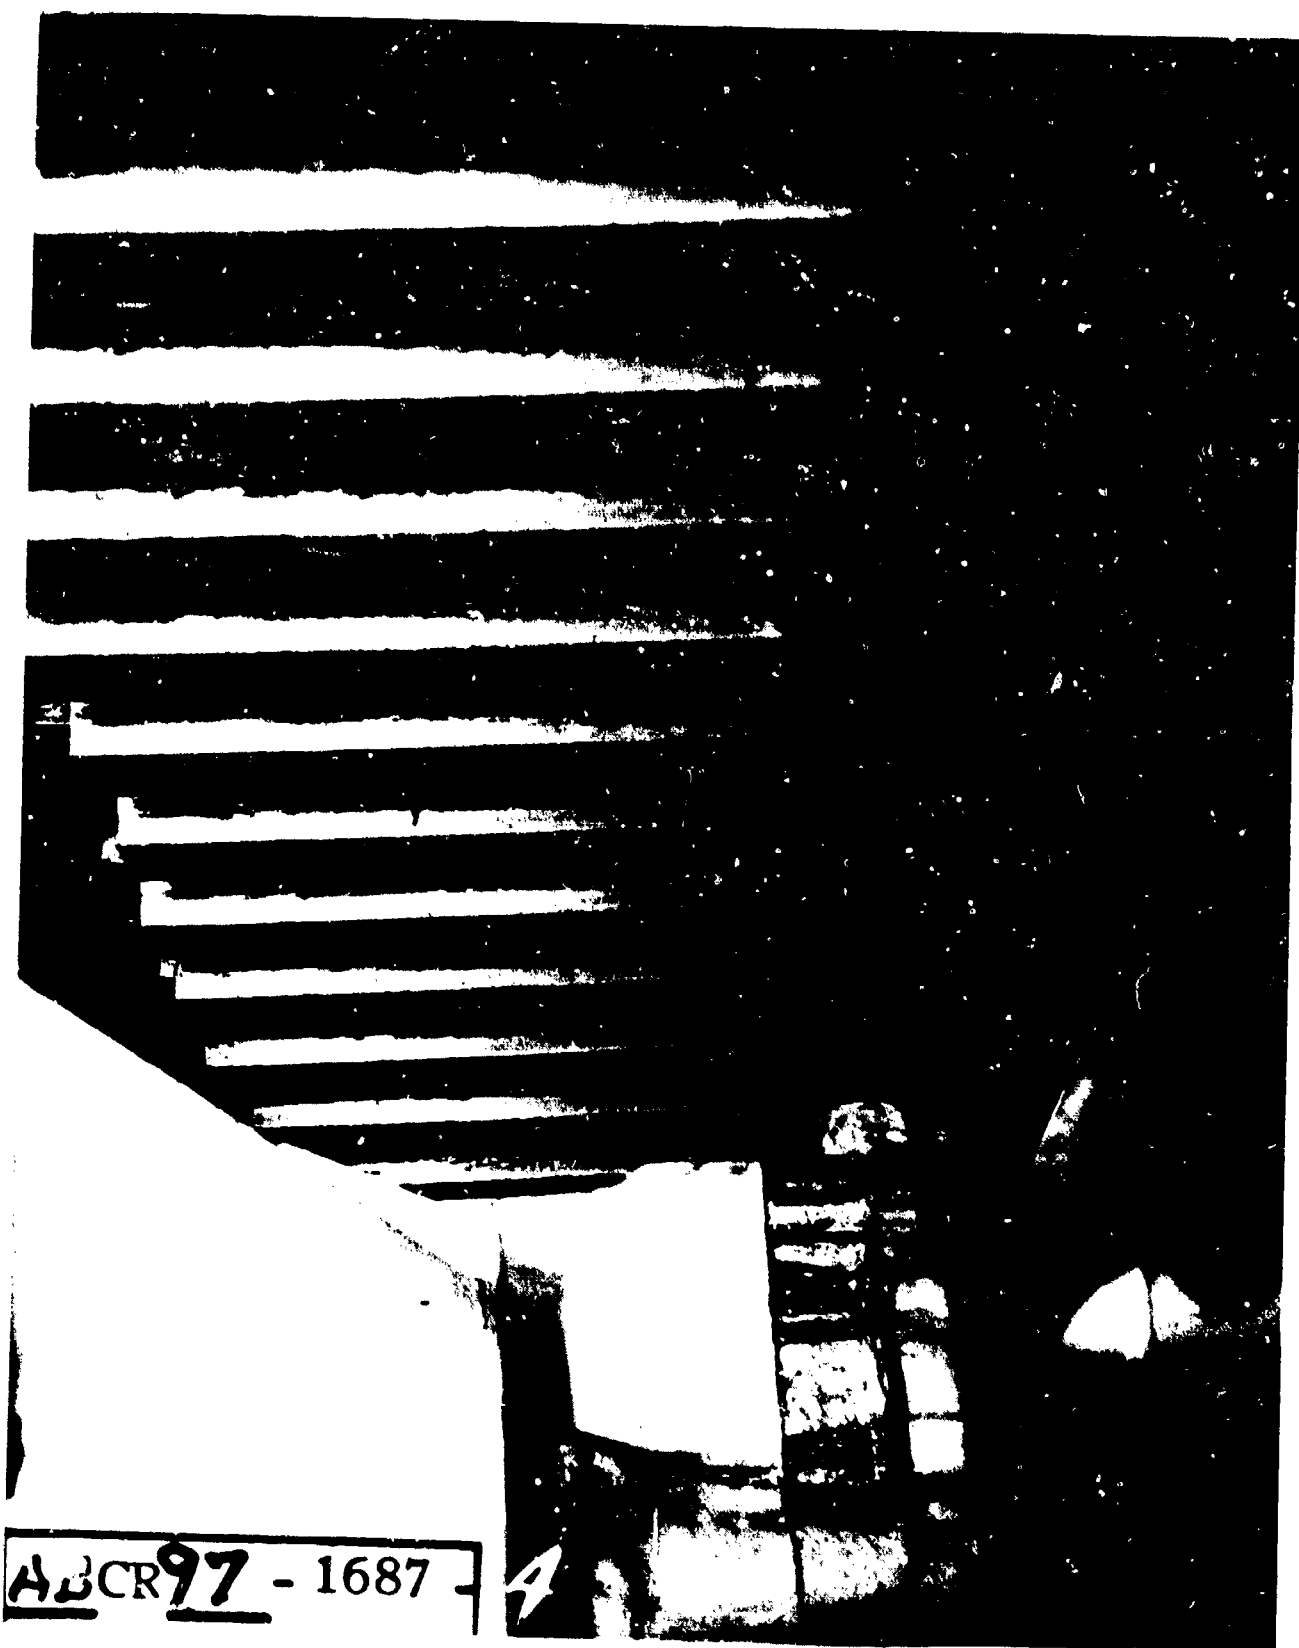
U.S.S. PENSACOLA (CA-24) - After Parker
Close up view of the training rack, Mt.
No. 3. Showing where the training rack
shifted upward.
Photo. No. Ab-Cr-97-1687-4.

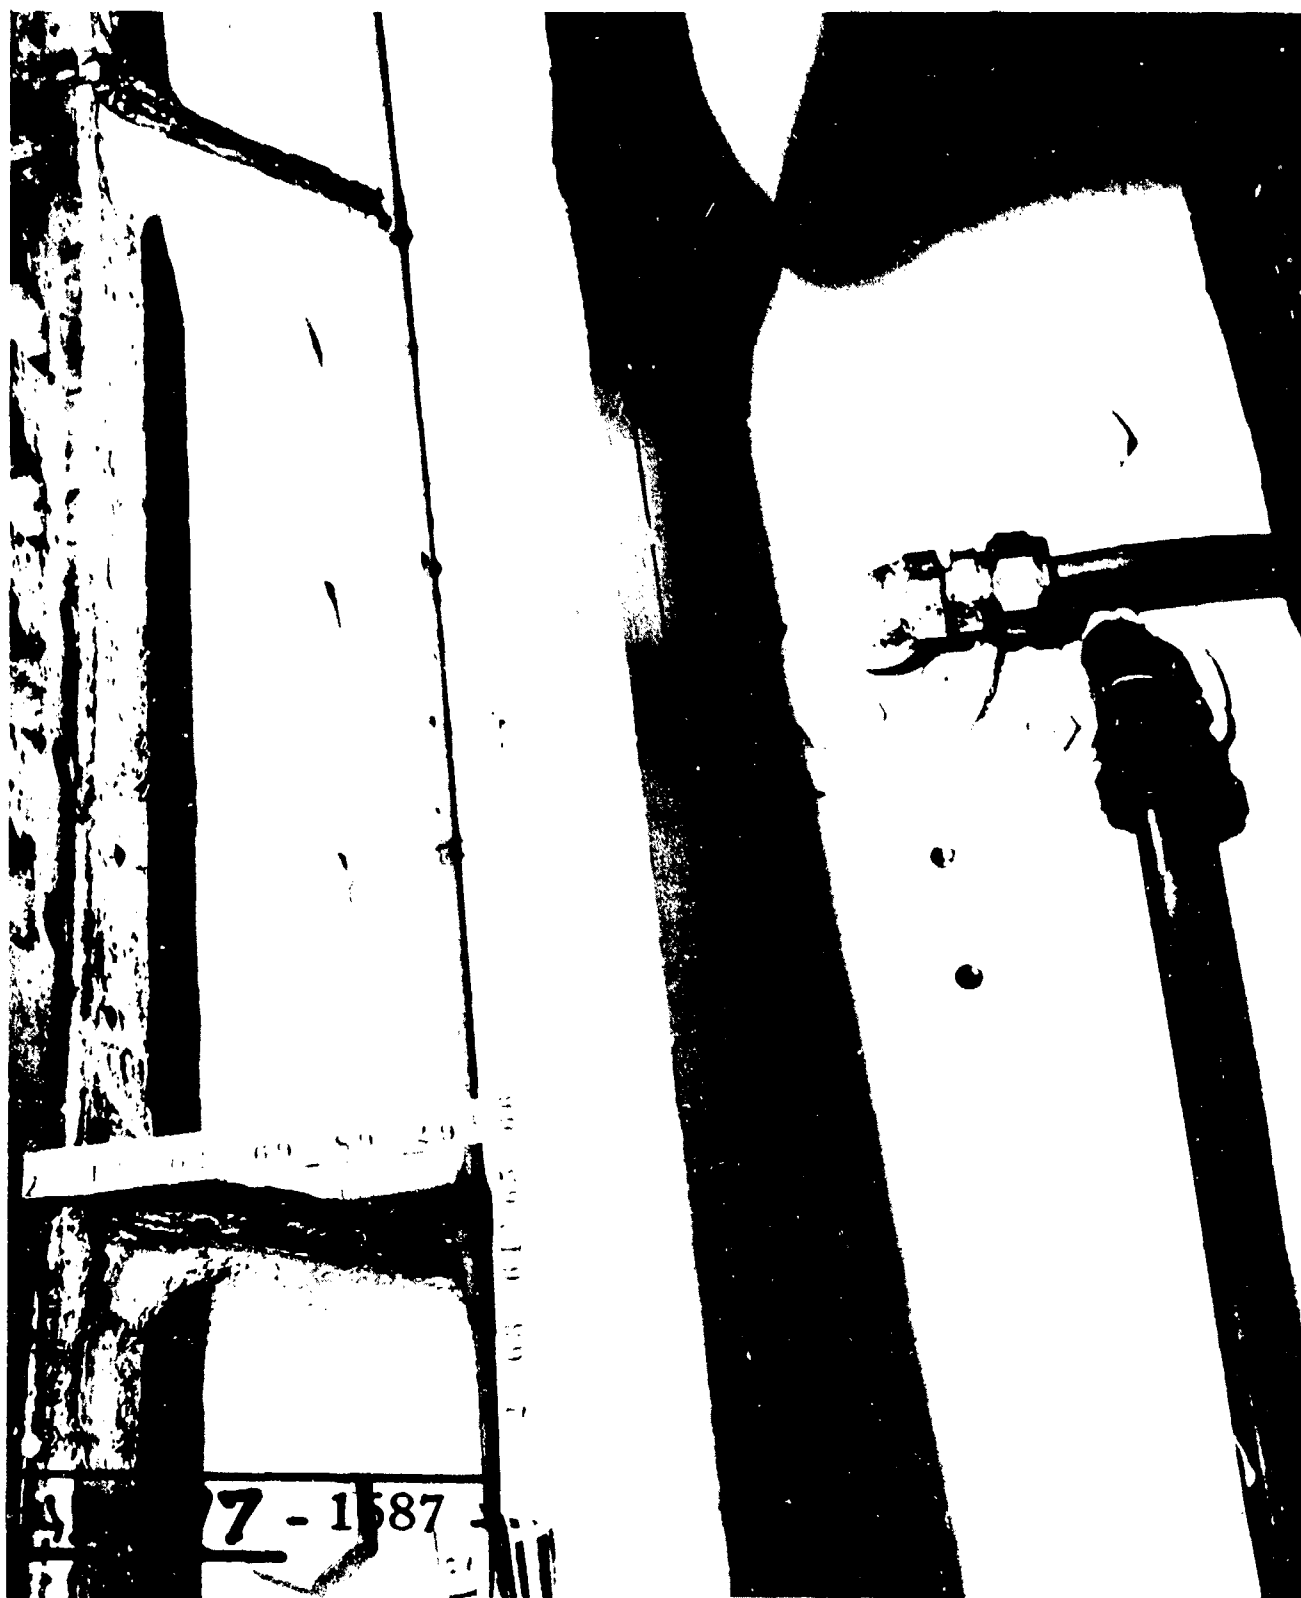
U.S.S. PRISACOLA (CA-4) - After dayer
 Close up view of the training rack of
 Mt. No. 3. Showing the amount the fwd.
 center line section of the training rack
 shifted upward.
 Photo. No. AB-CR-97-1687-5.

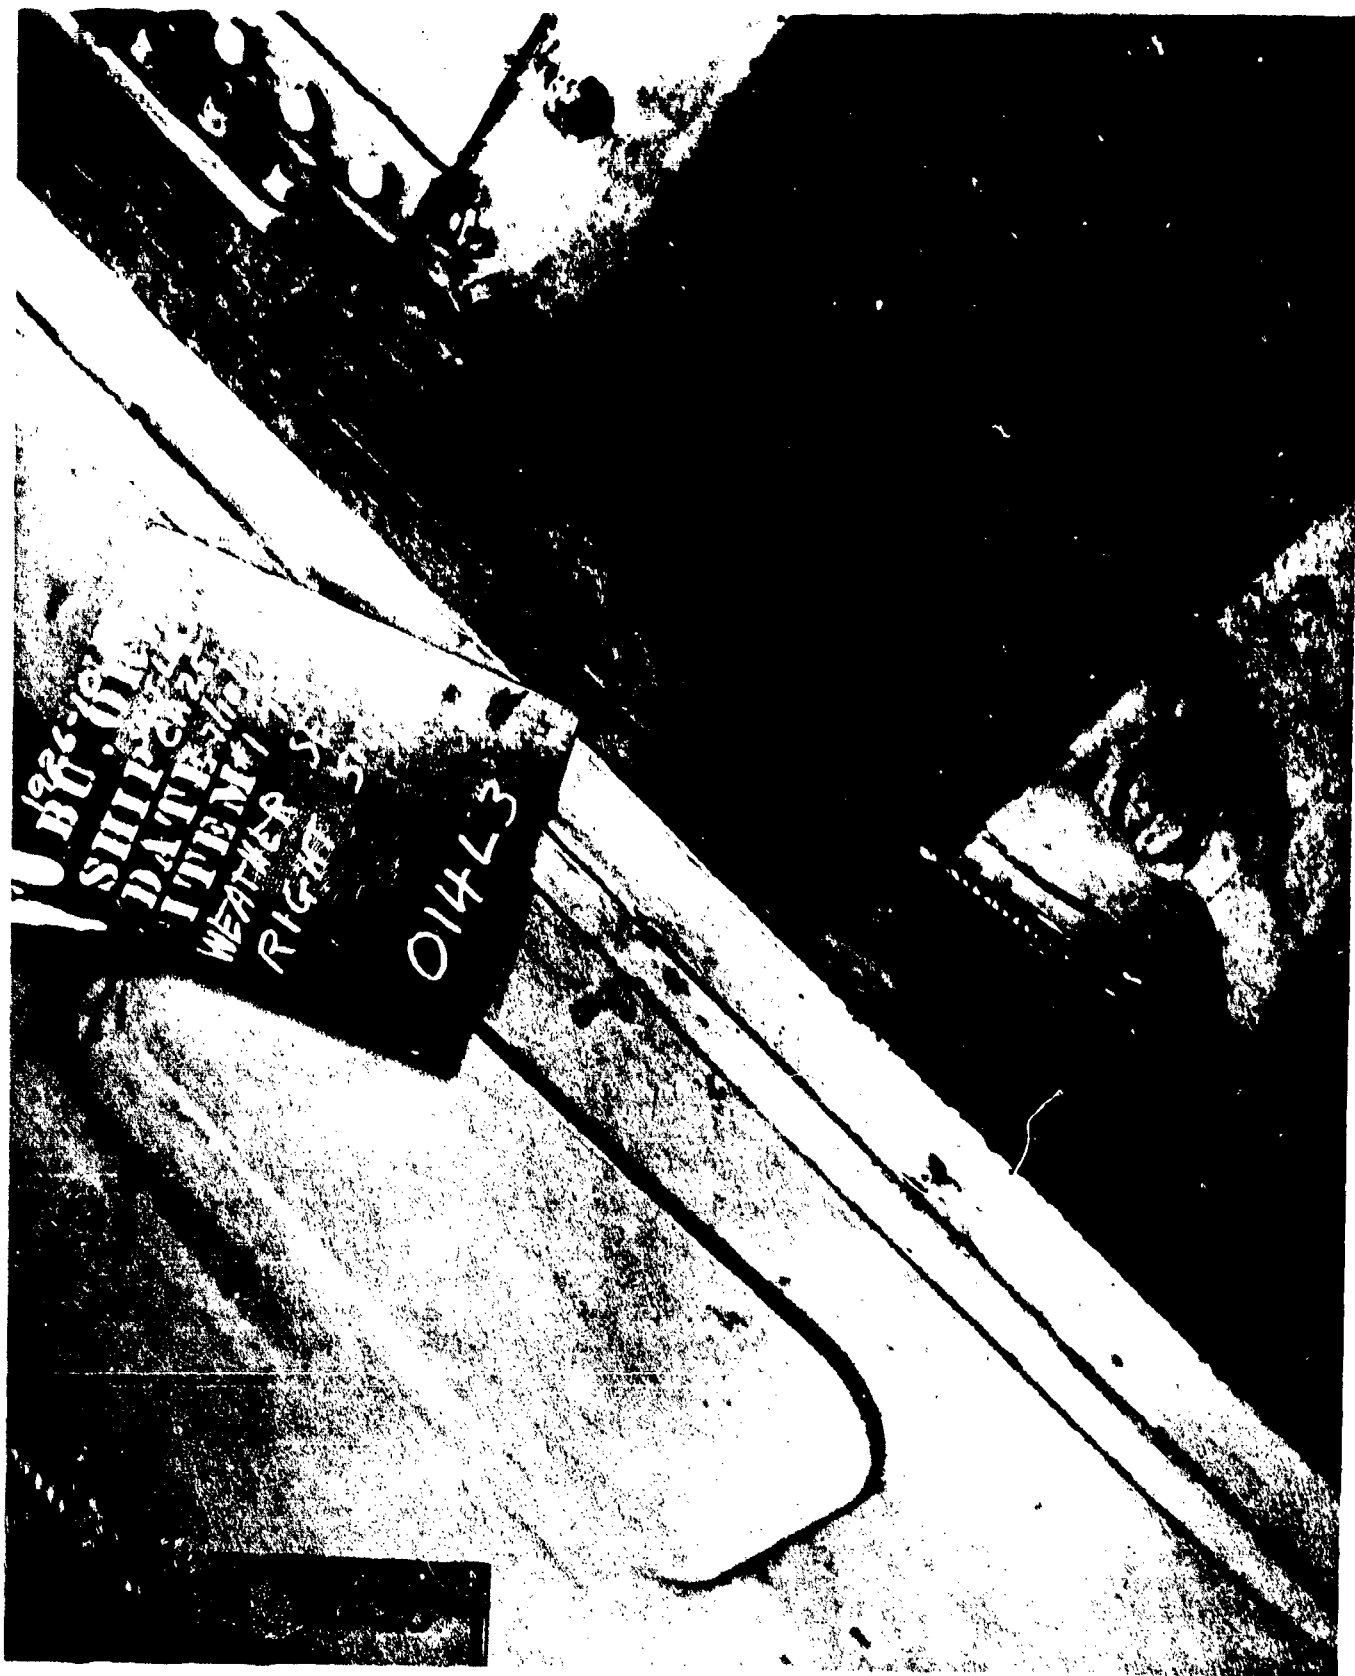
U.S.S. SALT LAKE CITY (CA-25) - After Able
View of 8"/55 Mt. No. 1 showing the blown
out weather seal, right side.
Photo. No. AA-GR 76-1926-10.

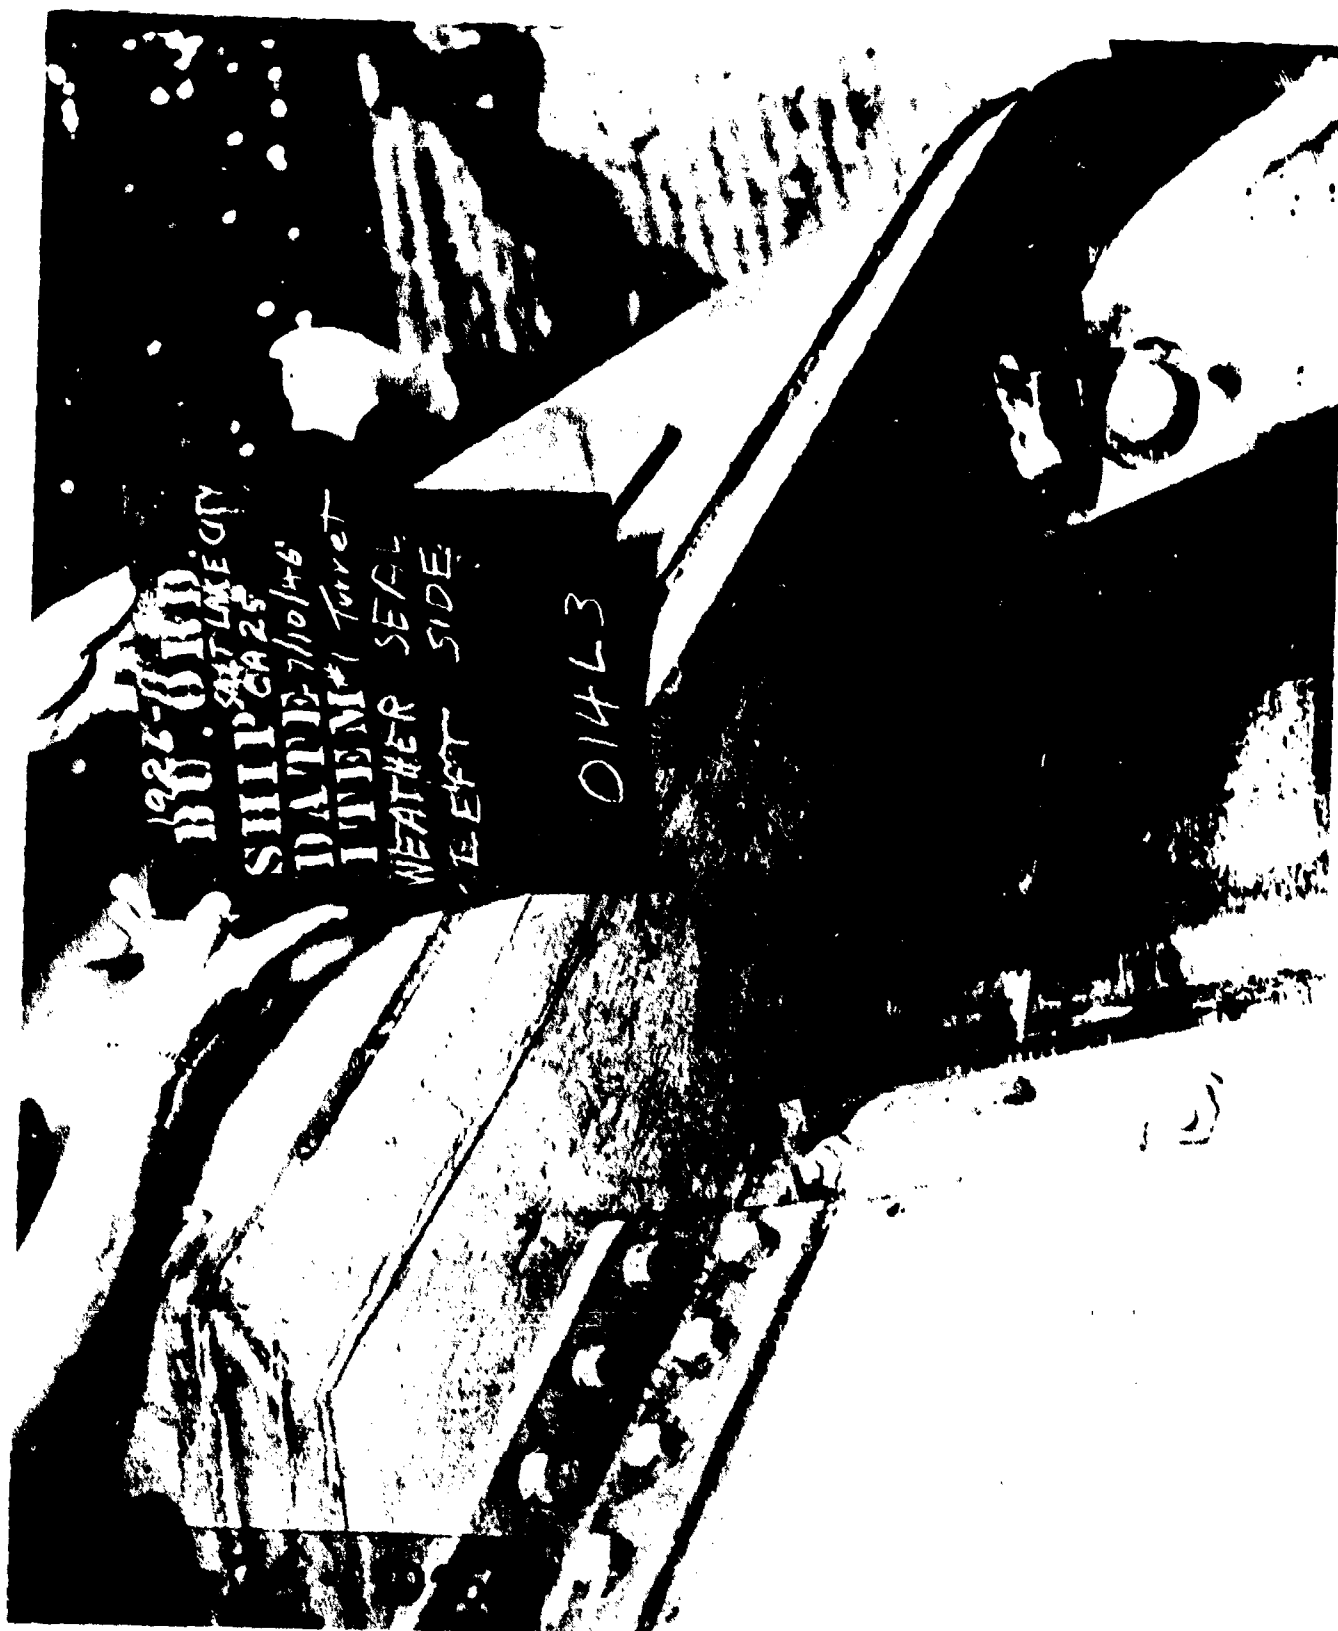
U.S.S. SALT LAKE CITY (CA-25) - After Able
View of 8"/55 Mt. No. 1 showing the blown
out weather seal, left side.
Photo. No. AA-CR-76-1926-11.

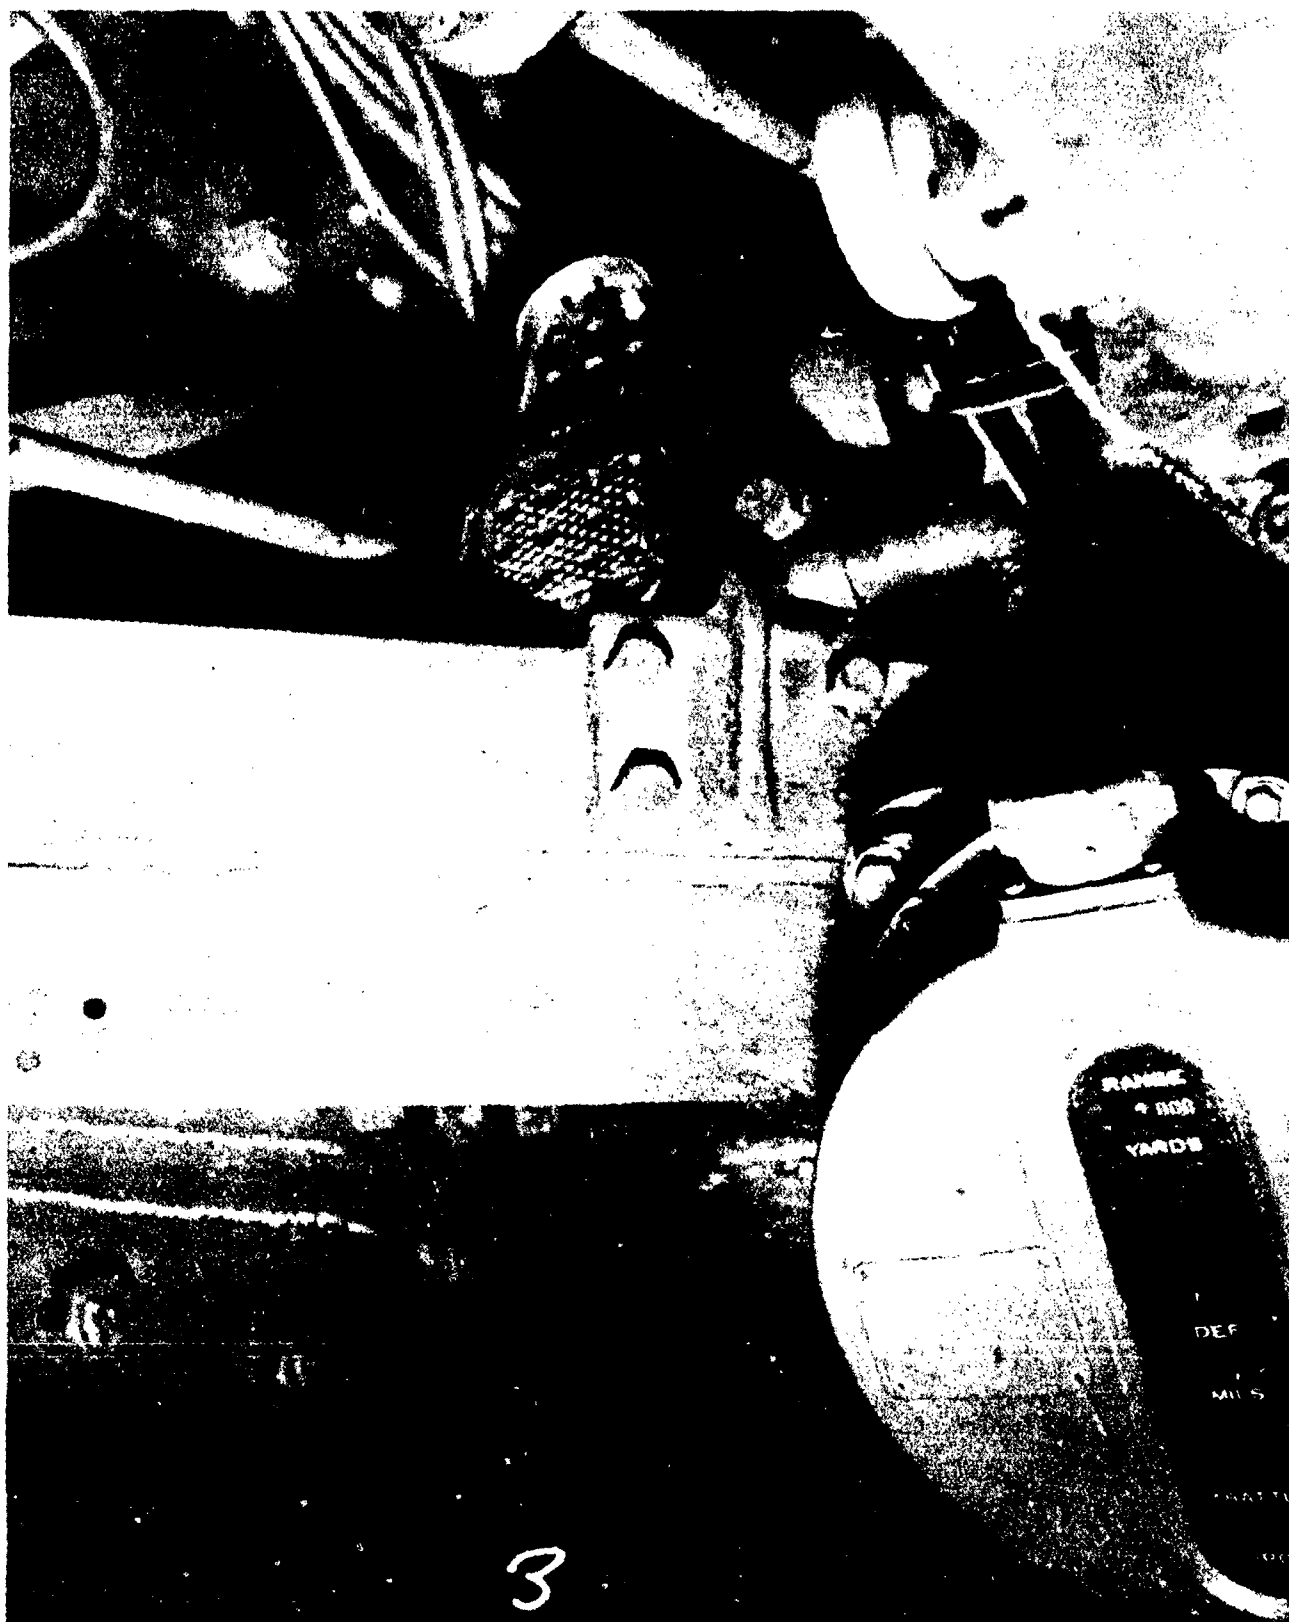
U.S.S. SALT LAKE CITY (CA-25) - After Able
Interior view of 8"/55 Mt. No. 1 showing the
cracked paint on the deck lug support, pointer's side.
Photo. No. AA-CR-76-1927-3.

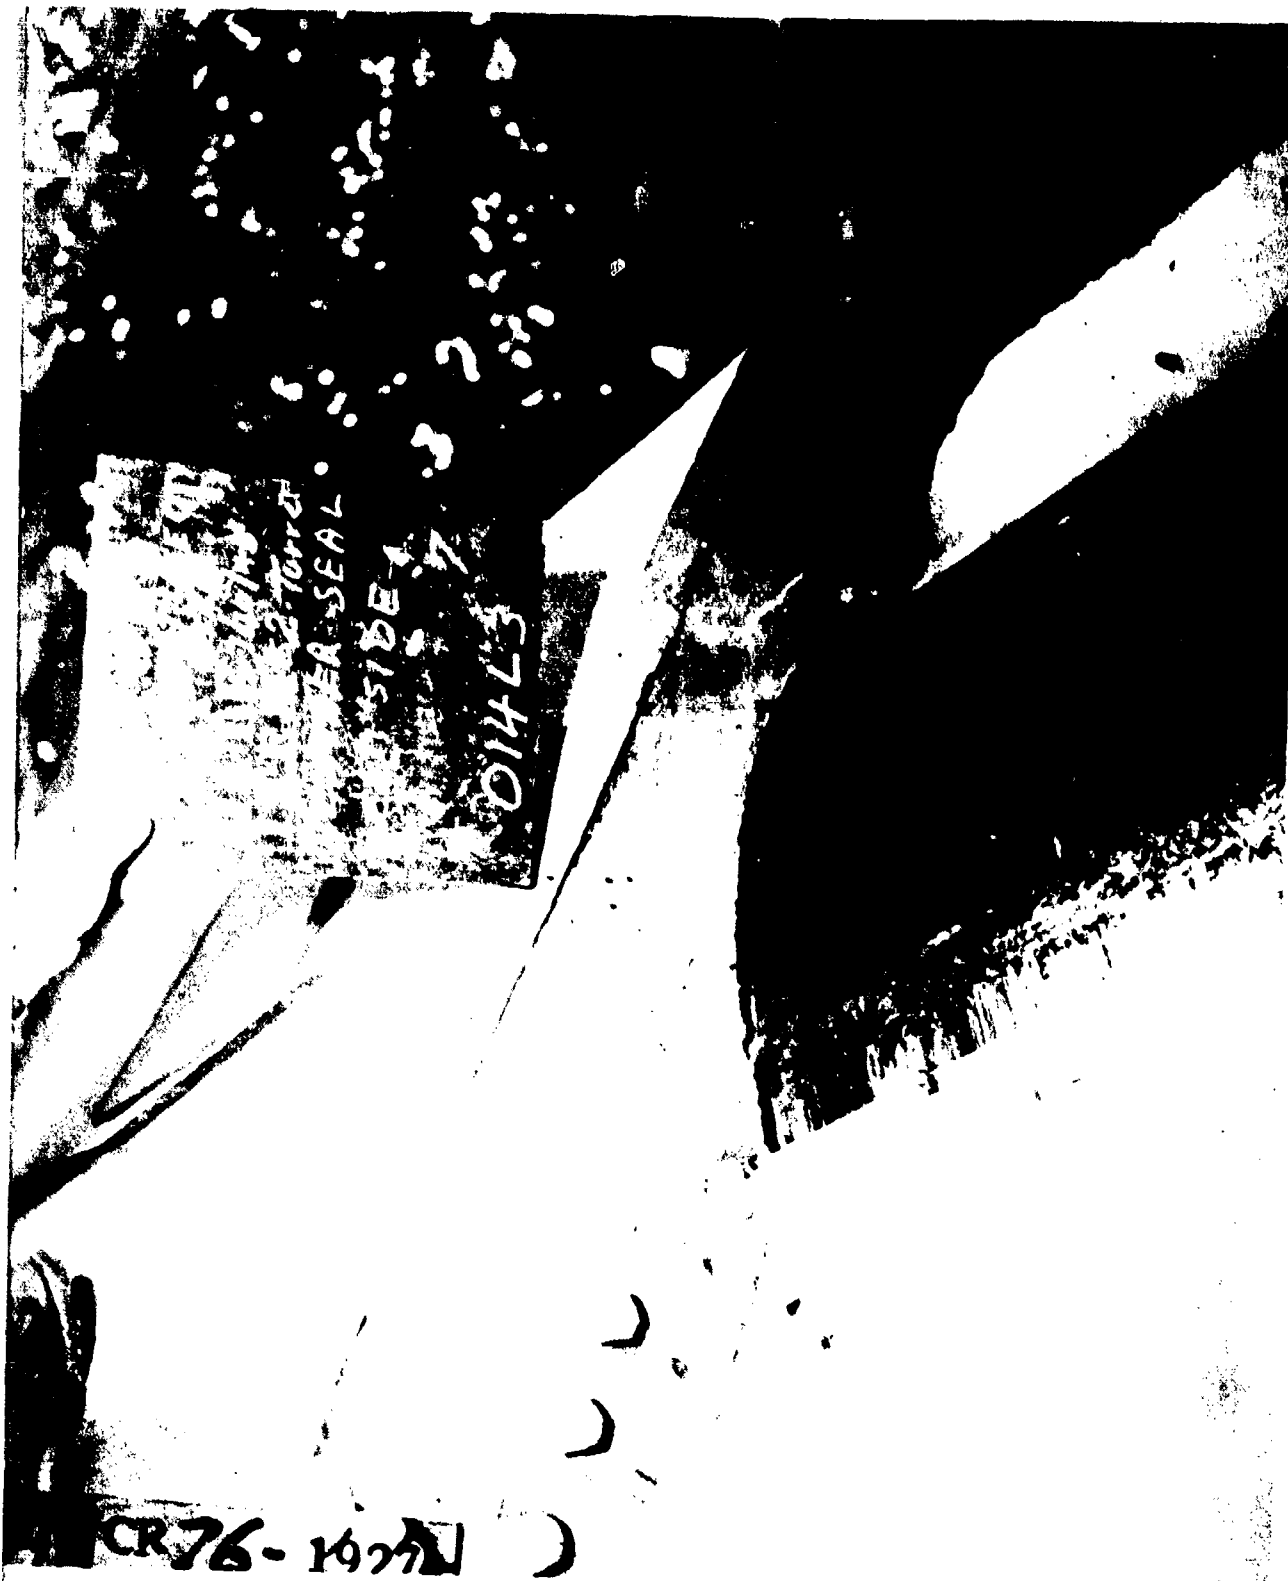
U.S.S. SALT LAKE CITY (CA-25) - After Able
 Exterior view of the left gun of 8"/55 Mt.
 No. 2 showing the blown out weather seal and
 the chipped paint on the face plate, showing
 that the slide shifted to the left.
 Photo. No. AA-CR-76-1927-6.

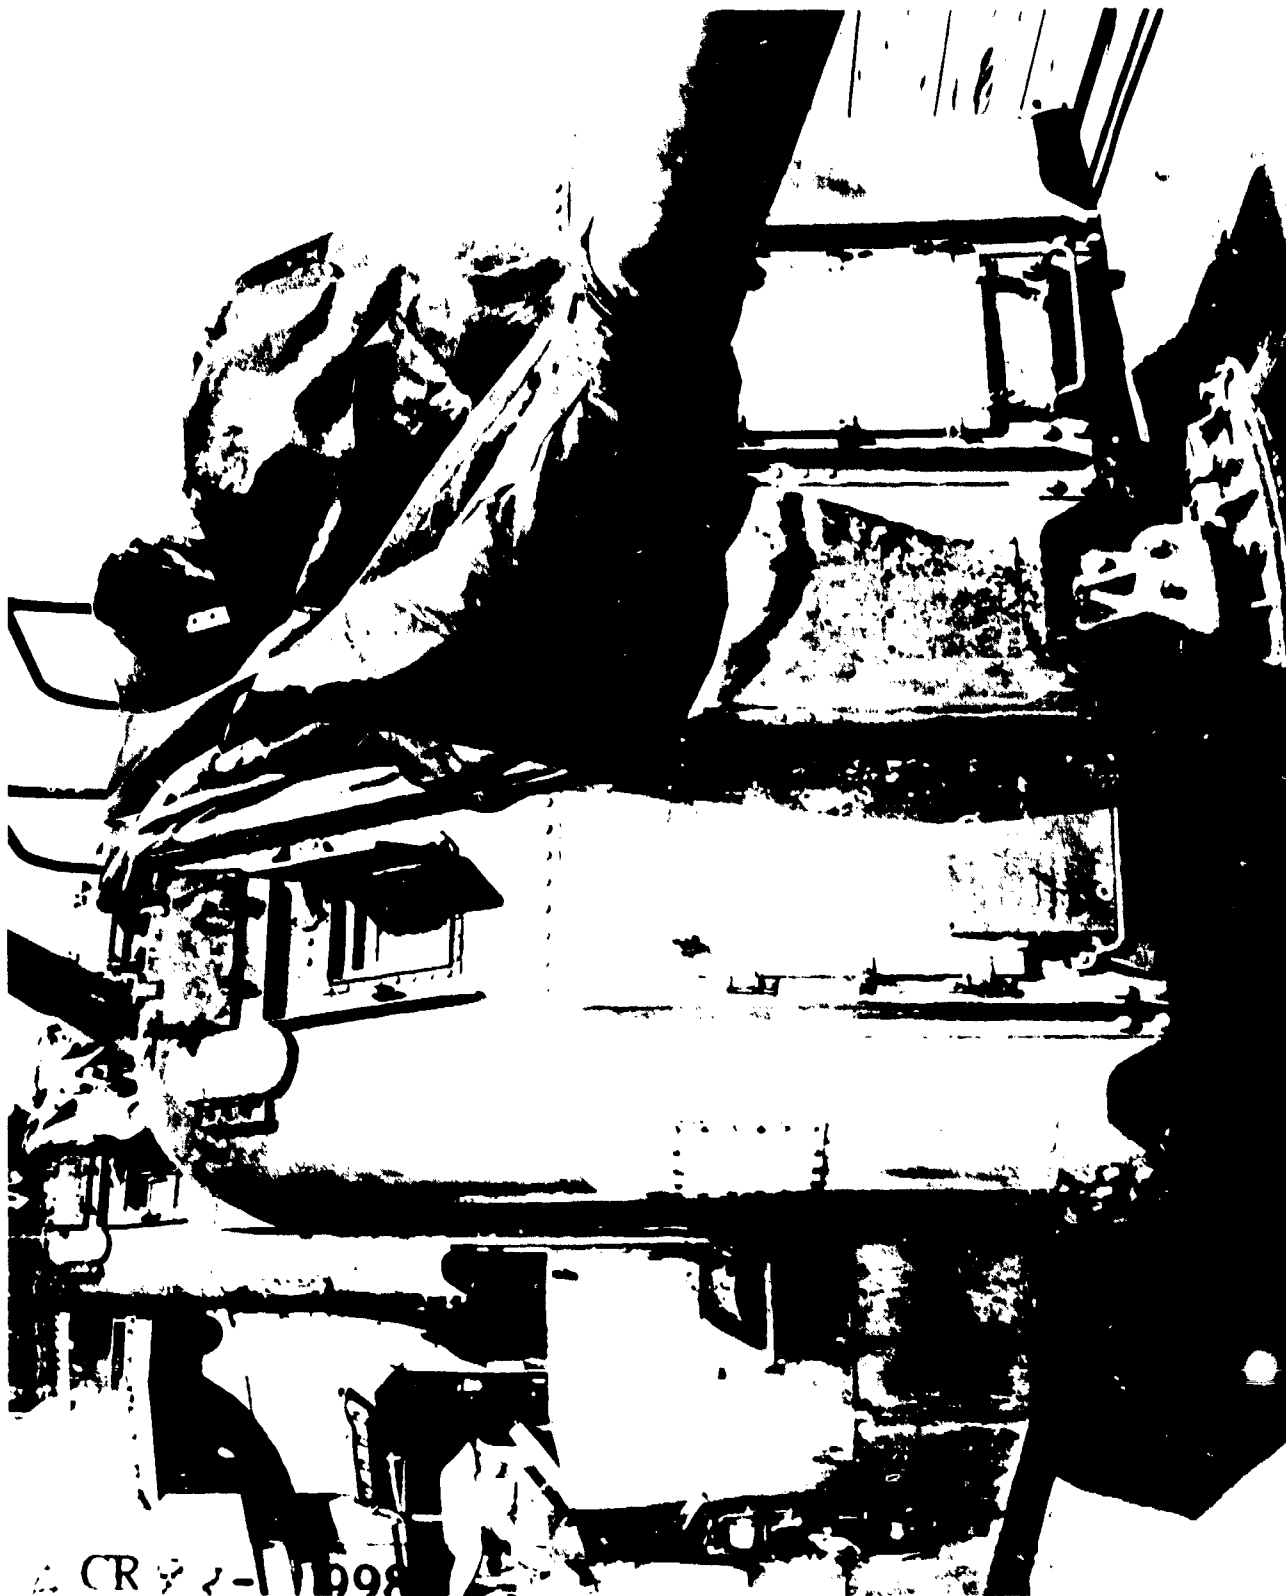
U.S.S. STACK (ID-406) - After Able
General view of 5"/38 Cal. Mt. No. 1
showing torn Gun Port Bloomer and scorched
exterior paint
Photo. No. AA-CR-93-1998-11.

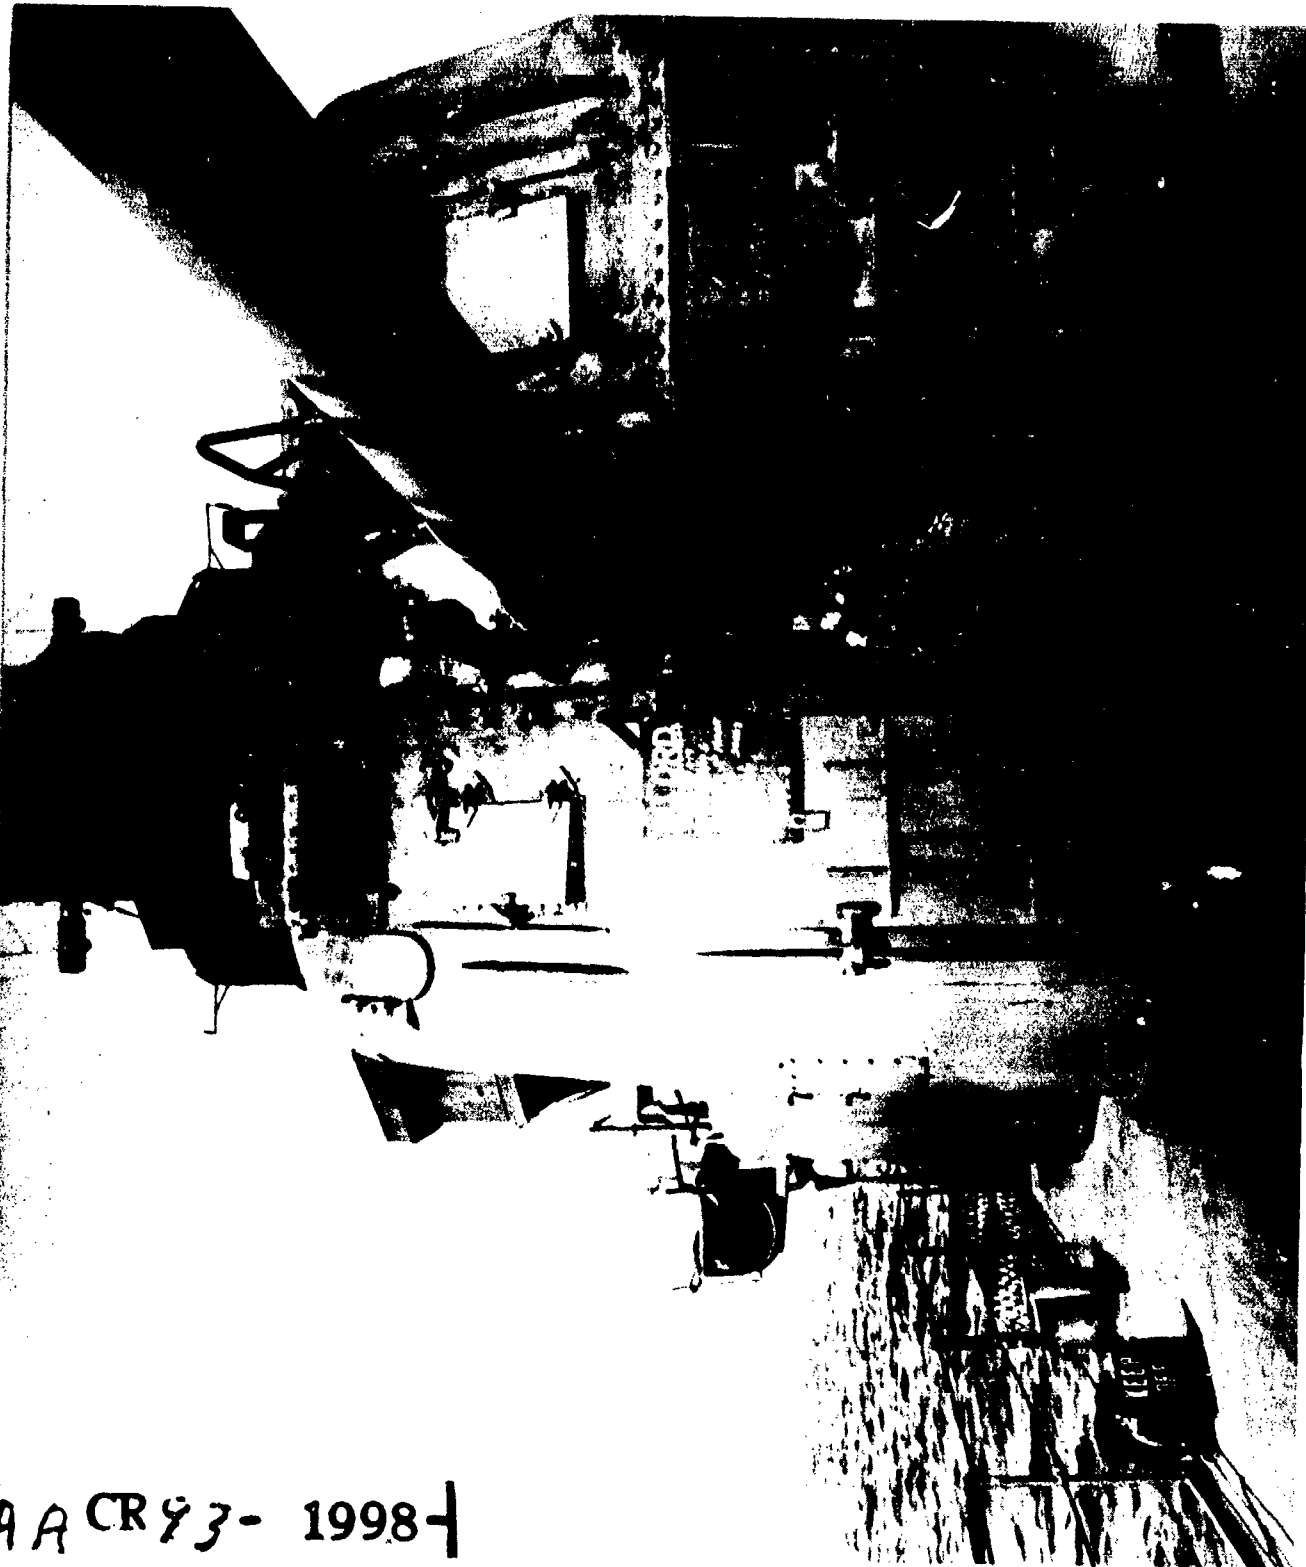
AA CR 93- 1998-

U.S.S. WAINWRIGHT (DD-419) - After Able
General view of 5"/38 Mt. No. 1,
Showing burned gun port gas seal and
scorched exterior paint caused by
burning Gun Port bloomer.
Photo. No. AA-CR-93-1998-7.

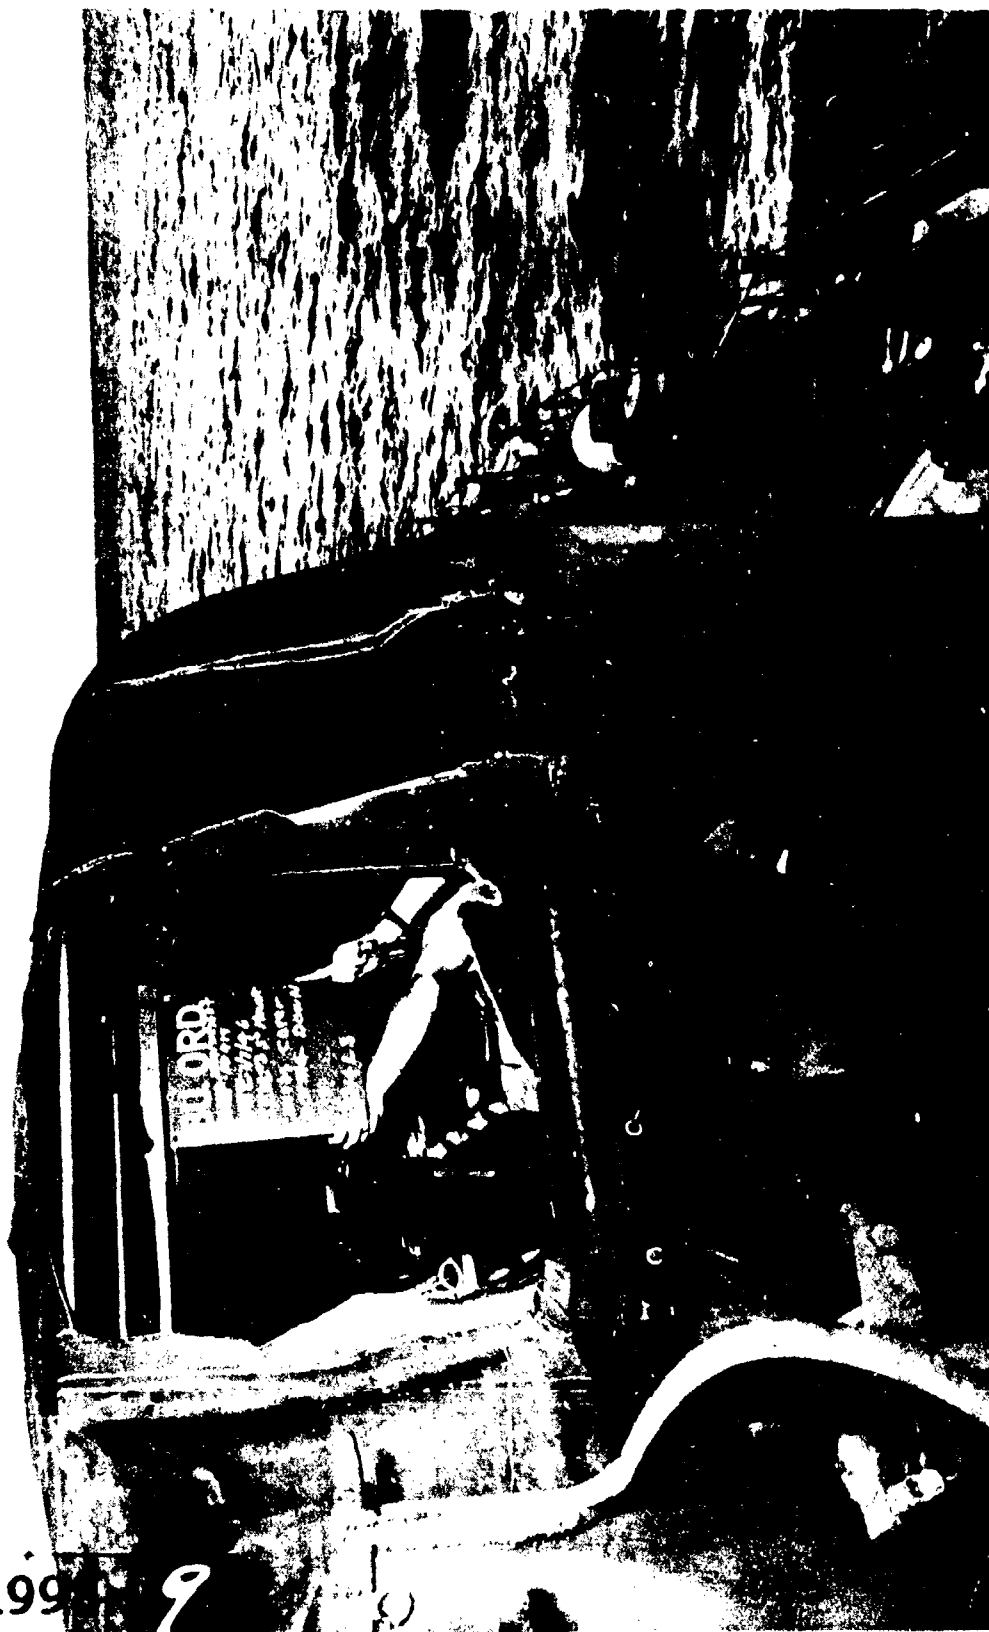
A CR 93- 1998-9

U.S.S. WAINWRIGHT (DD-419) - After Able
Close up of 5"/38 Cal. Mt. No. 3.
Showing torn canvas top.
Photo. No. AA-CR-93-1998-9.

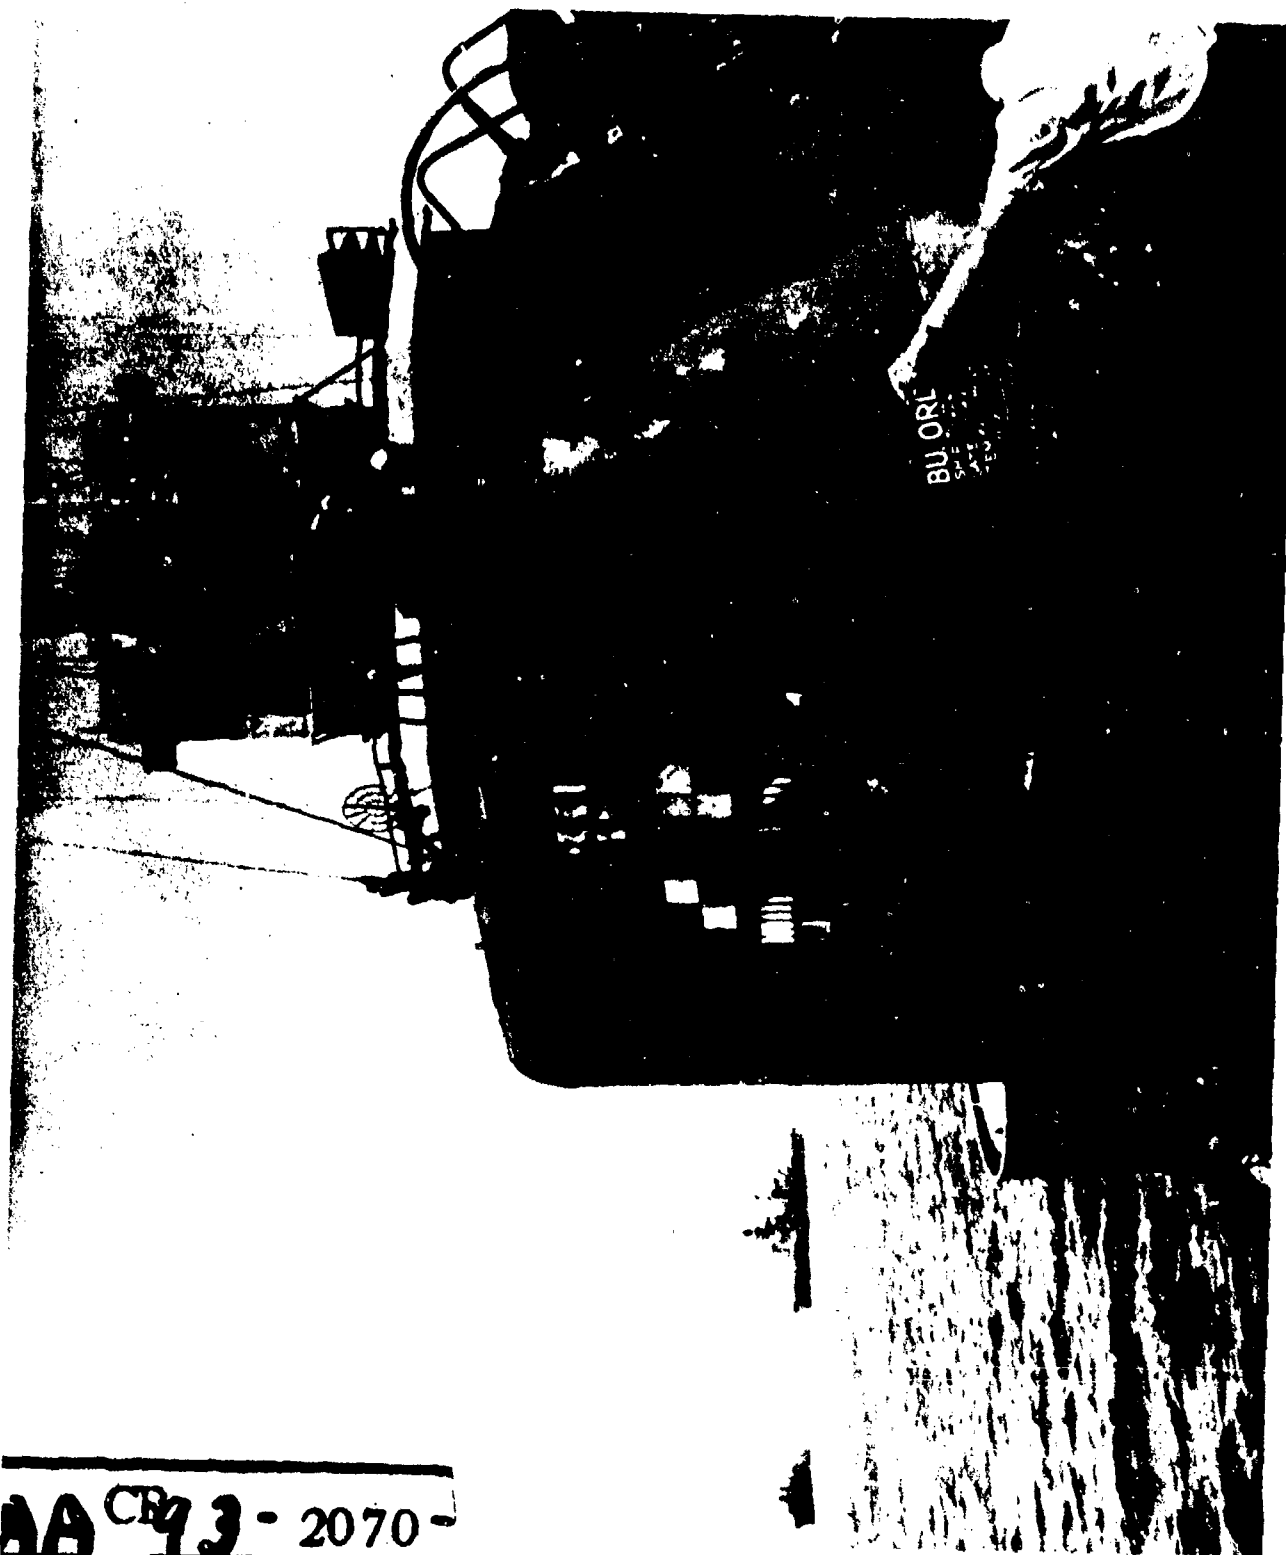
AA^{CR} 93-2070-

U.S.S. WILSON (DD-408) - After Action
Close up of 5"/38 Cal. Mt. No. 2.
Showing Gun Port Bloomer torn away and
scorched exterior paint.
Photo. No. AA-CR-93-2070-1.

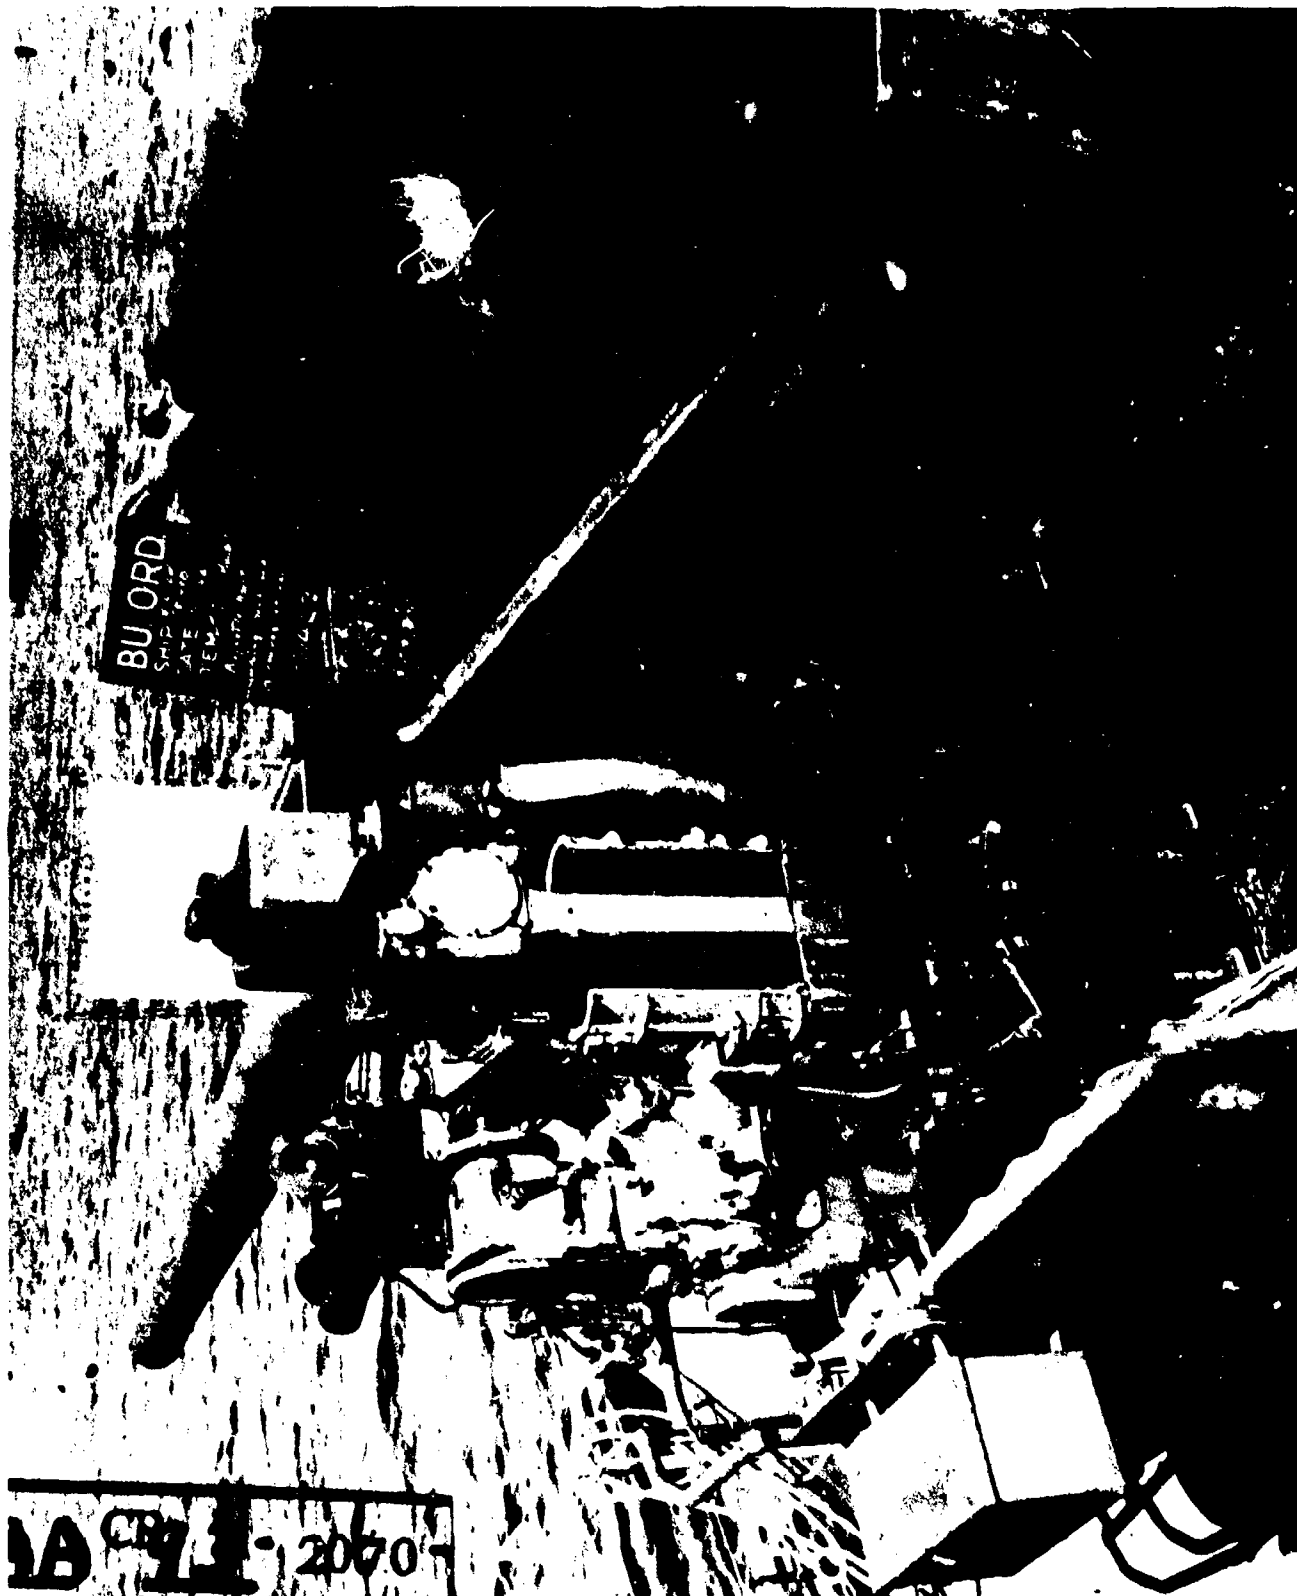
U.S.S. WILSON (DD-408) - After Able
 Close up of 5"/38 Cal. Mt. No. 3.
 Showing exterior paint on projectile hoist,
 rammer and pointer's station scorched.
 Photo. No. AA-CR-93-2070-4.
